TRIUMF

ANNUAL REPORT SCIENTIFIC ACTIVITIES 2002

CYCLOTRON OPERATIONS DIVISION

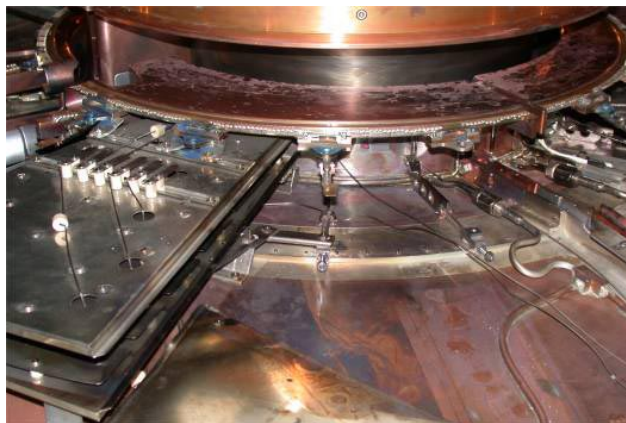
Fig. 185. View into Q1 from slightly above the median plane. The correction plate assembly is on the left.

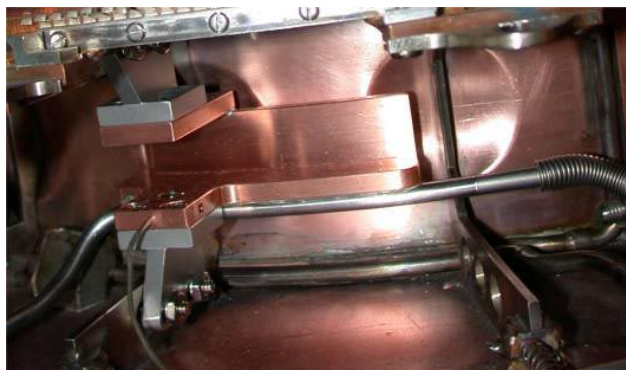
During the winter 2002 shutdown a great deal of effort was dedicated to improving the cyclotron centre region. Problems were being caused by excessive beam losses on uncooled surfaces in the first few turns. Radial beam losses on the vertical walls of the centre-region rf resonator quadrants were overheating the attached stainless steel reinforcing ribs. At high beam intensities the rib temperature rose above 120°C, triggering protection trips. To solve this problem a water-cooled beam absorber was installed immediately after the injection gap to intercept a large portion of the beam that had previously been hitting the quadrant walls. To install the absorber, the centre region detachable quadrant 1 (Q1) was removed from the cyclotron. Figure 185 shows a centre region view looking towards Q1 before the beam absorber installation. The beam absorber attached to the vertical wall of Q1 is shown in Fig. 186.

Fig. 186. Cooled beam absorber installed in Q1.

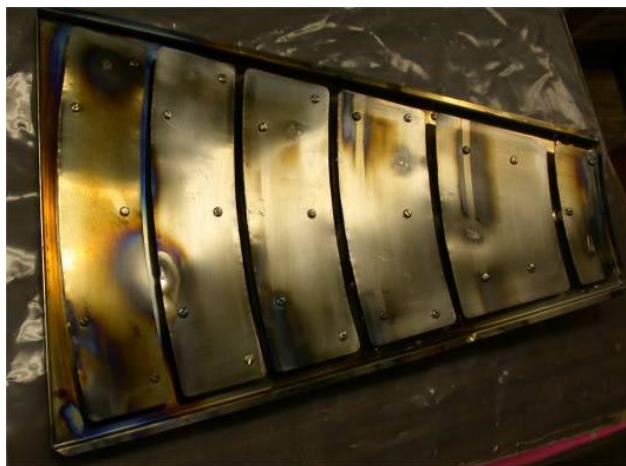
Next the quadrant 1 correction plates (CP) (see Fig. 187) were removed from the tank. A detailed inspection of the plates showed a number of deficiencies:

1. The upper tray, which houses the plates, was bent 0.3 in. down toward the median plane of the cyclotron.
2. Evidence of the beam hitting plate 5, one of the plates closest to the median plane, was observed (see Fig. 187).
3. The plates had been made from thin stainless-steel sheet and required realignment.
4. A few ceramic insulators were cracked and/or broken.

5. Some of the insulators near plates exposed to the beam were spattered with metal.

Fig. 187. Q1 correction plates. Notice beam damage spot on the left.

Repairs were made during the shutdown. All damaged insulators were replaced, and the plates were straightened and reassembled. The correction-plate trays were reinstalled and realigned to specifications.

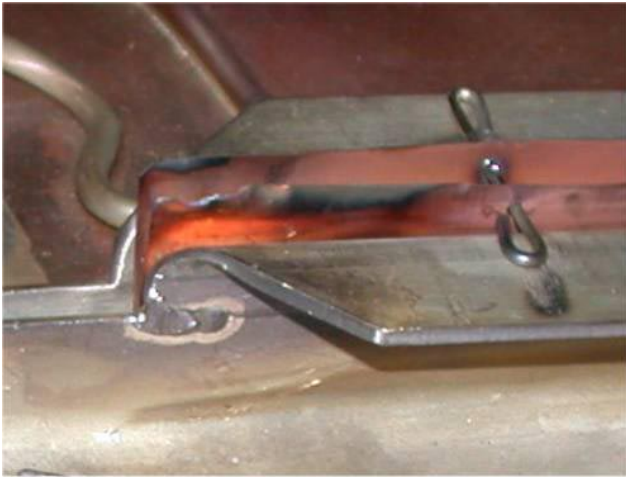
Fig. 188. Protruding M-foil, damaged by beam.

Then it was found that the M-foil, designed to provide a good rf connection between adjacent resonators (see right-hand side of Fig. 185), was sticking up into the dee gap. There it was exposed to the beam that caused melting (see Fig. 188). To prevent this from happening again, the excess foil material was trimmed away. Finally, to improve temperature monitoring in the centre region, four new thermocouples were installed and two old thermocouples were relocated.
