# ANNUAL REPORT SCIENTIFIC ACTIVITIES 2003

CANADA'S NATIONAL LABORATORY FOR PARTICLE AND NUCLEAR PHYSICS

DECEMBER 2004

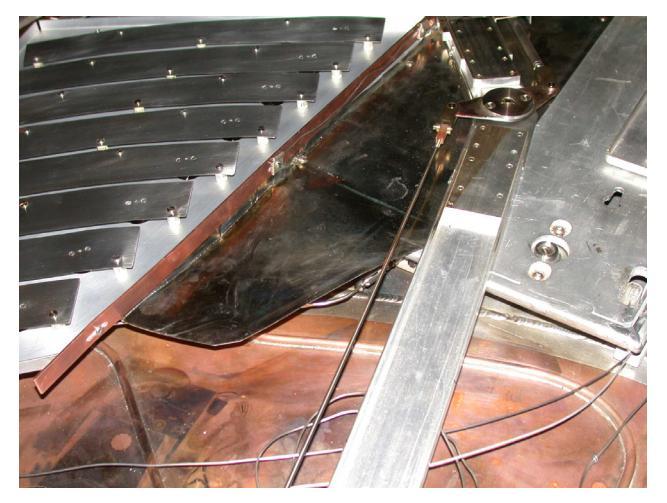
Each of TRIUMF's centre region quadrants contains electrostatic correction plates for vertical steering. Figure 231 shows how each upper and lower set of plates is mounted on a tray fastened to the dees. Vertical beam scrapers have been attached to the leading edges of the trays. As shown in Fig. 232, the thermocouples, mounted on the upstream side of the

Fig. 231. Quadrant 4 lower correction plates showing the beam scraper and thermocouples.

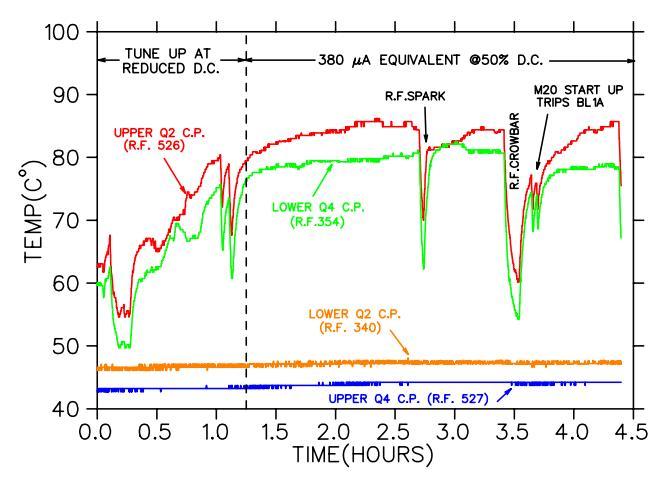
Fig. 232. Quadrant 2 and 4 correction plate thermocouple readings versus time with 380  $\mu A$  peak current at 50% duty cycle.

scrapers, show that the beam heats up the upper scraper in quadrant 4 and the lower scraper in quadrant 2. The other scrapers remain cool. Some beam development time was devoted to trying to understand this phenomenon, and it is now thought to be caused by misalignments of the trays. These will be corrected in 2004. In addition, the thermocouples will be moved from the upstream to the downstream side of the scrapers to make sure that they are measuring the scrapers' temperature and not just responding to direct hits by the stray beam. Hopefully these measures will solve the problem.

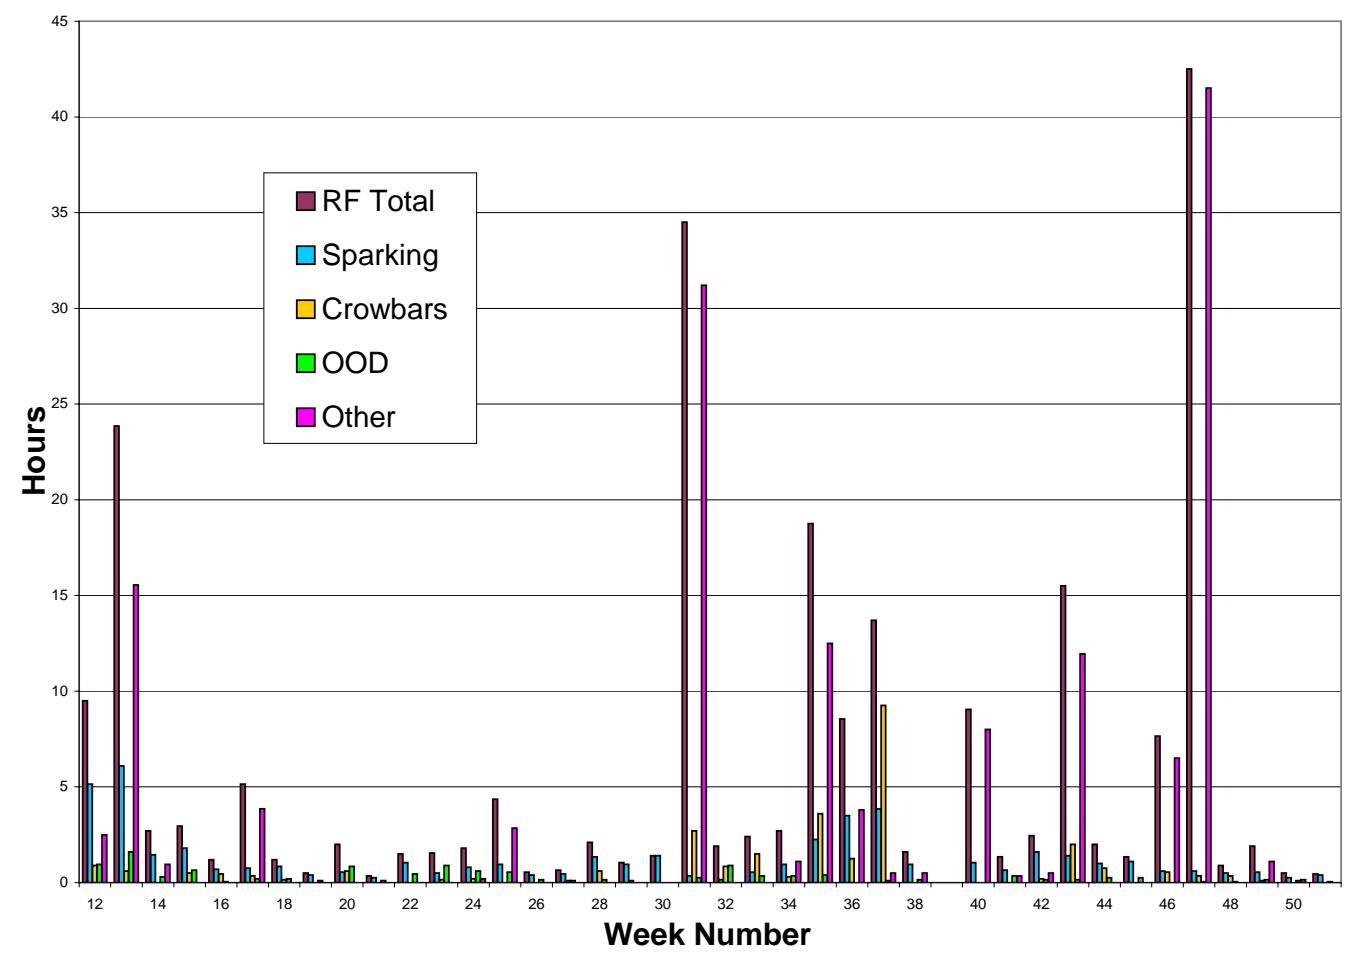
A detailed weekly downtime chart is shown in Fig. 234. Bars on the histogram represent the accumulated number of hours over a one week period that were lost while the system recovered from a specific failure. The failures are grouped into four categories: sparks, high voltage power supply (HVPS) crowbars, rf self-excited (out of driven (OOD)) mode, and other, which represents unique hardware failures. It is obvious that the largest part of the downtime ( $\sim 62\%$ ) was attributed to unpredictable failures of major hardware (the Other category). Among these was the failure of a resistor in the 250 kW waster. This caused heavy sparking in the transmission line and substantial damage to it (see Fig. 235). On another occasion, damage to the transmission line was triggered by parasitic-mode excitations in the rf combiner. Both failures demonstrated a deficiency in protection of the system against a high standing wave ratio (VSWR) in the transmission line. Interlock circuitry is being developed that triggers rf drive cutoff in the case of high VSWR.

Fig. 234. 2003 rf system downtime.

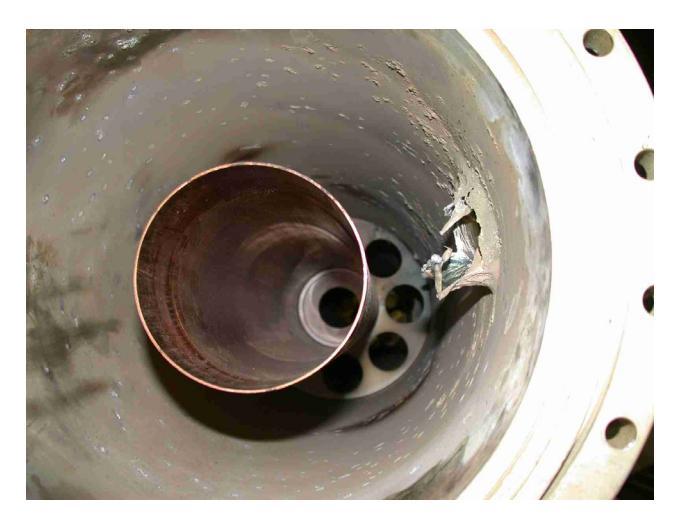
Fig. 235. Spark-damaged 9 in. transmission line.

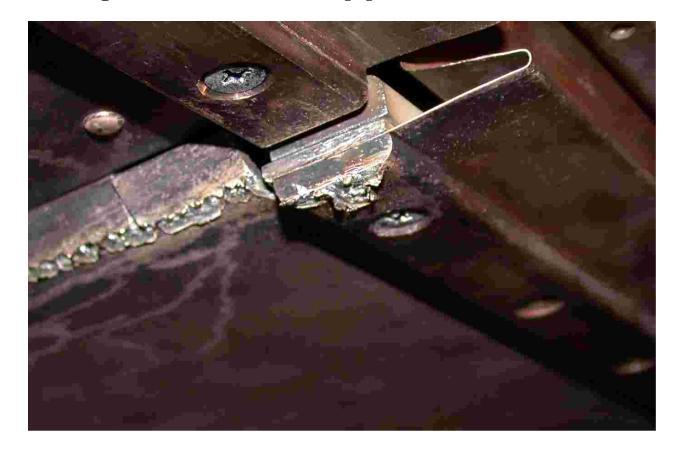
During the winter shutdown an extensive program was carried out to improve reading of the cyclotron voltage probes. There are 64 probes installed at every resonator ground-arm panel (excluding resonators number 1 and 10). Six broken voltage probes were repaired and the readings of all 64 probes were recalibrated. This involved measurements of the capacitance of the pickups and the positions of the resonators ground-arm-tips (GAT) and hot-arm tips (HAT), fixing the 20 Db attenuators, and calibration of the adjustable rectifiers (64 channels). GAT positions were measured directly in the rf gap using a special tool (see Fig. 236). This operation was very delicate and associated with a personnel radiation exposure of 3.62 mSvfor the  $\sim 150$  measurements. Apart from the distance calibration, we were able to identify a few spots of damage to the resonator panels caused by rf breakdowns (see Fig. 237) and parasitic rf currents across adjacent

Fig. 237. UQ2 resonator number 3 spark damaged panel.

panel junctions. Problems were observed between resonators number 3 and 4 in quadrants 2 and 3. Eroded surfaces were polished and bent finger contacts were straightened to fix this problem.

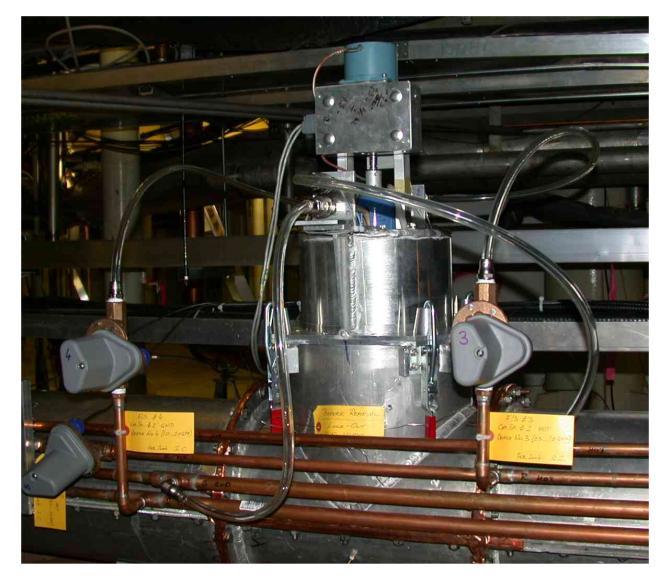
An upgrade to a fast replaceable capacitor station number 2 was implemented in the matching section of the transmission line (see Fig. 238). A major modification of the cooling circuit for all the capacitor stations that will provide higher reliability and serviceability was included. New capacitor stations numbers 1 and 3 were prepared for installation during the next shutdown.

Fig. 238. New capacitor station number 2.
