TRIUMF

ANNUAL REPORT SCIENTIFIC ACTIVITIES 2004

**CANADA'S NATIONAL LABORATORY
FOR PARTICLE AND NUCLEAR PHYSICS**

CYCLOTRON OPERATIONS DIVISION

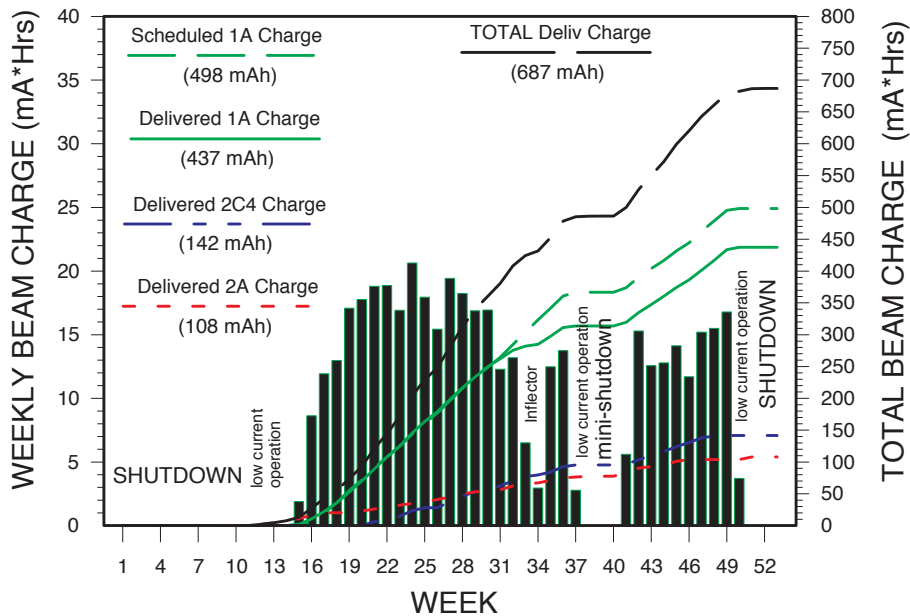
Fig. 181. Beam delivery for 2004.

As Fig. 181 shows, the total beam charge delivered to meson hall experiments along BL1A was 437 mAh or 88% of the scheduled amount, down marginally from last year because of vacuum and target considerations described below. In addition to the BL1A charge, there were a significant 142 mAh delivered at 85 MeV to rubidium targets in the solid target facility (STF) in beam line 2C4 for the production of radiopharmaceutical generators and another 108 mAh, 30% more than last year's record, delivered to the two target stations on BL2A for the production of radioactive ion beams (RIB) for experiments in ISAC. A total extracted current exceeding $220 \mu\text{A}$ was sometimes shared by the three proton lines, although $200 \mu\text{A}$ or less was more normal for extended production periods. This was par-

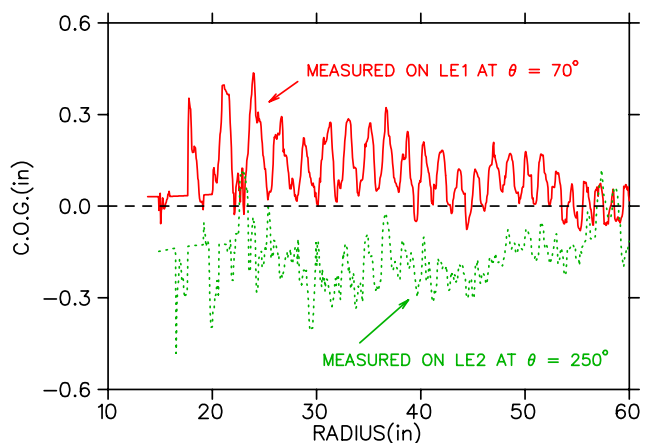
Fig. 183. Vertical positions of beam centroids measured on opposite sides of the tank with LE1 and LE2.

After the above improvements, the position of the centroid of the beam was measured on opposite sides of the tank with LE1 and LE2. As shown in Fig. 183, the beam is higher on LE1 in quadrant 1 than it is on LE2 in quadrant 3. The reason for this median plane tilt is not entirely understood, however, a theoretical analysis done during TRIUMF's early construction suggests that it could be caused by dee mis-alignments. A median plane tilt could also be a contributing factor to the overheating of diagonally opposite upper and lower correction plate scrapers described above.

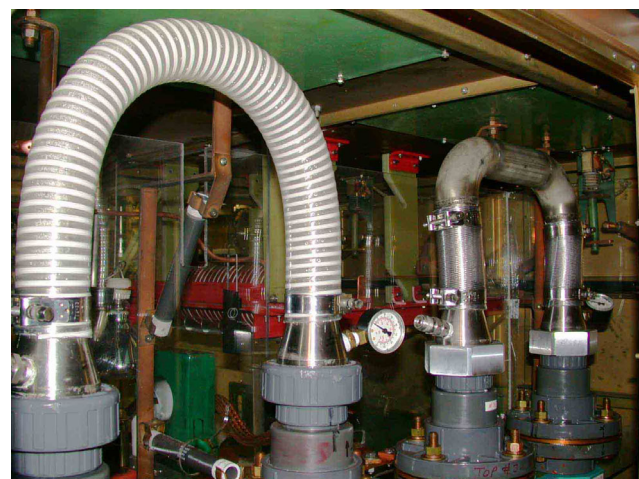
Fig. 188. Old and new (left to right) flexible couplings in the HVPS resistor cooling circuit.

New thyrite varistor stacks with additional air cooling were installed in the main HVPS to improve protection of the chokes (see Fig. 187). Horn spark gaps on the chokes were readjusted to the specified rating. New flexible couplings for the water-cooled resistors were installed because the old ones often cracked and gave a lot of trouble with water leaks. Both the old and the new type of connections are shown in Fig. 188.

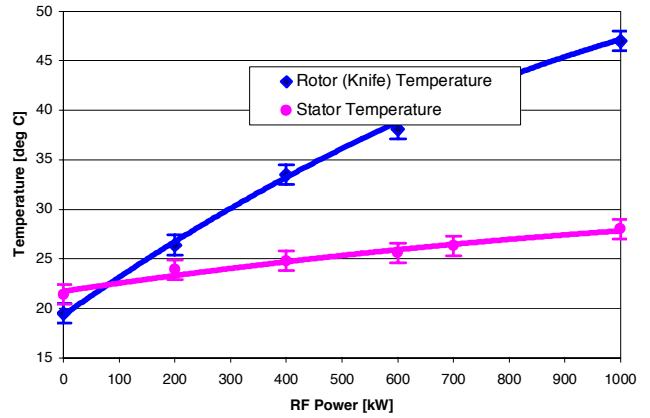
Fig. 193. RF switch temperatures vs. rf power.

In June the switch was successfully tested at full power in the cyclotron. This time we extended the length of the transmission line (including the switch) by about 5 m in order to move a transmission line resonance away from the operating frequency. The measured temperatures at the rotor (knife) contact and the water-cooled stator contact group are presented in Fig. 193, and show a minor temperature rise which will not affect the reliability of the operation of the system. The rf switch and soda solution load are being upgraded now with commissioning planned for 2005 winter shutdown.

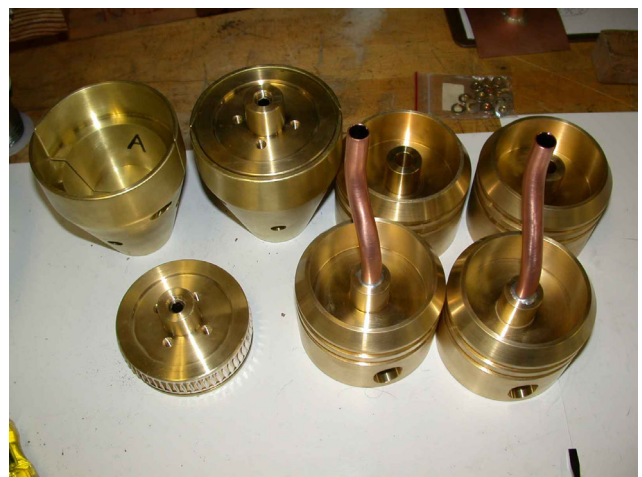
Fig. 194. Parts for new transmission line cooling design.

seals were installed. Old rubber gaskets, installed some 20 years ago, were found hardened (carbonized), especially in the vault area where they are exposed to radiation. The transmission line water cooling circuit was redesigned. The original design was based on a plastic return pipe buried inside a centre conductor of the transmission line. This pipe was found to be completely disintegrated due to radiation damage. The new design uses an external copper return pipe and requires new combiner adapter cones and centre-conductor water plugs with plastic pipes going out of the transmission line (see Figs. 194 and 195). The new design separates the cooling circuit for active branch from that of the non-active branch.

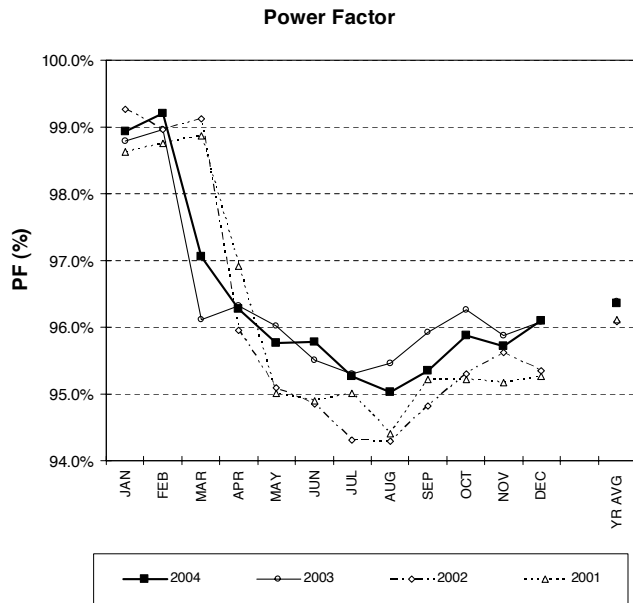
Fig. 204. Electrical system power factor – four year comparison.

The power factor (PF), averaged over the calendar year, remained flat at 96.4% (Fig. 204) despite increased activities. This effect can be attributed to the work of the additional capacitor banks in ISAC. The average load duration – the indicator of how well we use our power demand – has increased just slightly by 1.6% to 88.1% (Fig. 205).
