TRIUMF

ANNUAL REPORT SCIENTIFIC ACTIVITIES 2005

CYCLOTRON OPERATIONS DIVISION

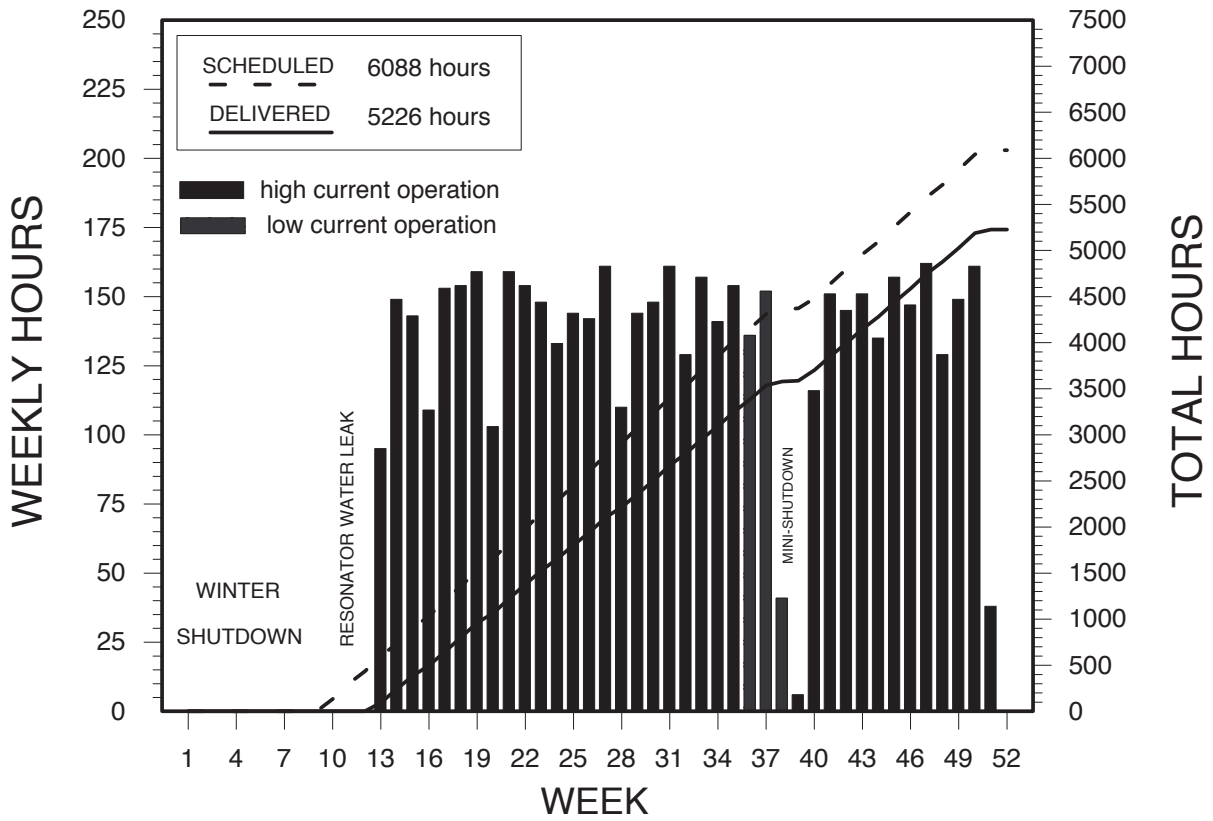
Fig. 248. Operational hours for 2005.

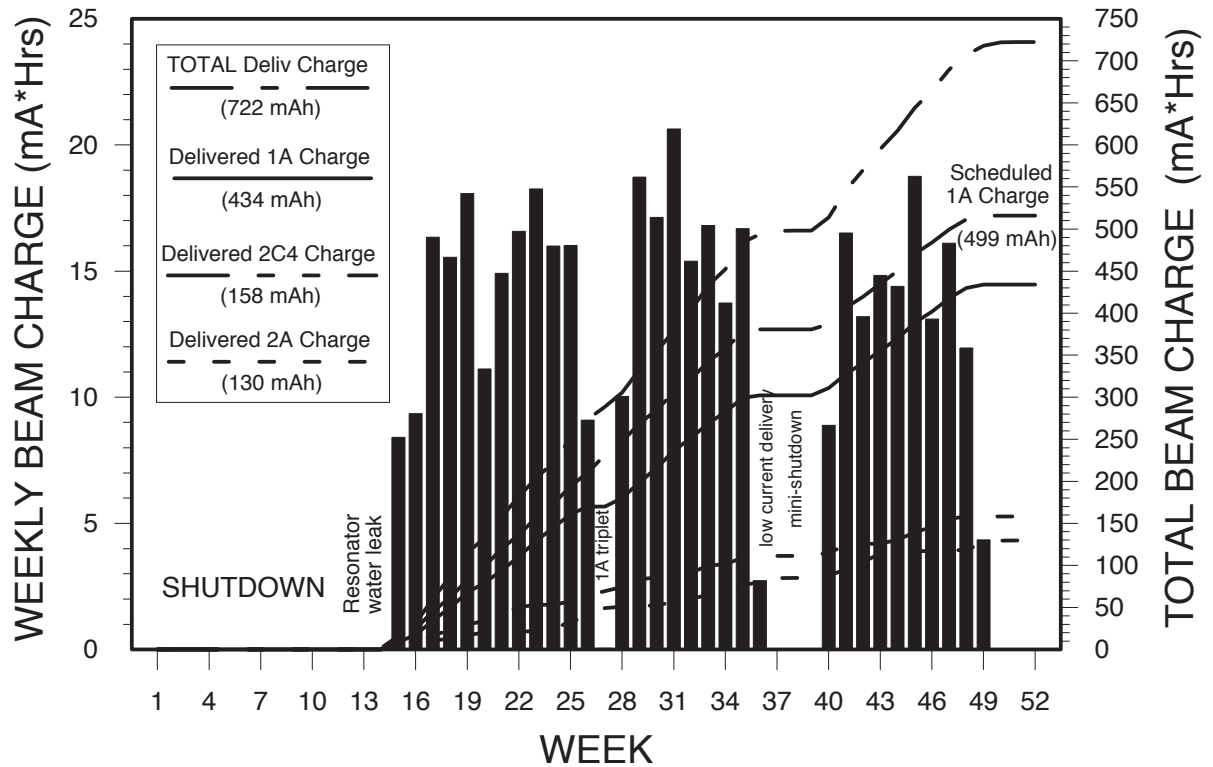
Fig. 249. Beam delivery for 2005.

As Fig. 249 shows, the total beam charge delivered to meson hall experiments along BL1A was 434 mAh or 84% of the scheduled amount, similar to last year,

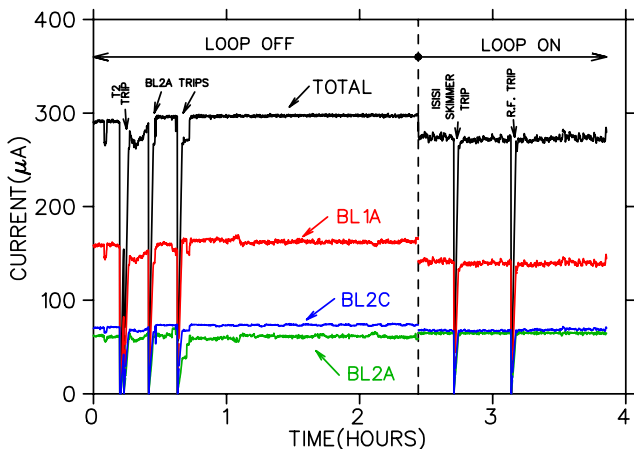
Fig. 251. Graph showing simultaneous extraction of high-intensity currents versus time with and without the BL2A pulser stabilization loop.

was broken. 298 μA was extracted at 97.2% duty cycle for 2.4 hours with 60% cyclotron transmission. The duty cycle was then reduced so that the stabilization loop could be turned on, and 274 μA was extracted for 1.4 hours. As shown in Fig. 251 the extracted currents were fairly stable, and turning on the feedback loop improved the stability of the current delivered to BL2A. Although these results are promising, further refinements of the tune and/or the hardware may be required before we will be able to reliably deliver 300 μA to experiments for weeks or months at a time.

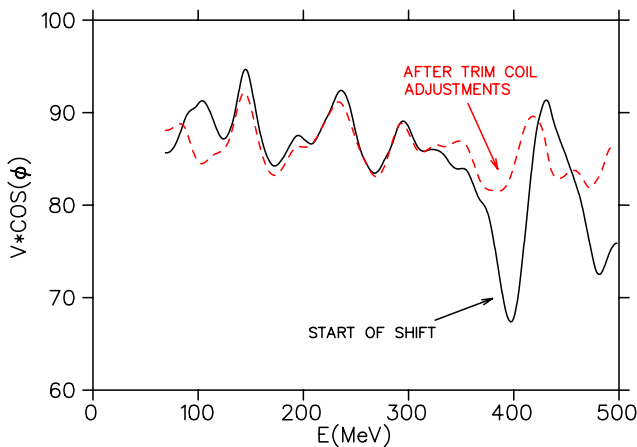
Fig. 252. HE1 $V \cos \phi$ scans showing how the isochronism was improved near 400 MeV by adjusting the trim coils.

This yields a measure of the product $V \cos \phi$. The dip near 400 MeV, indicating poor isochronism, was corrected by adjusting the trim coils.

Development time was also used to diagnose and correct problems that arose during beam production. Routinely at the start of each development shift, a complete set of diagnostic scans is done and existing problems are corrected before proceeding with the scheduled development. Figure 252 shows one such problem that was corrected. The HE1 probe is scanned while the time-of-flight between cyclotron injection and extraction is recorded as a function of the HE1 radius.

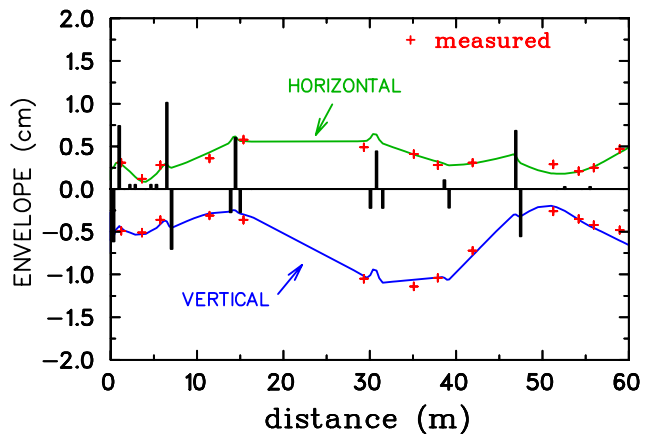
Fig. 253. Measured and calculated BL2A beam envelopes.

In 2005, a new BL2A tune was developed for ISAC. The old tune produced a dense 1 mm \times 2 mm spot which melted holes in the target. The new tune has been operational since April, 2005 and produces a less dense 12 mm spot ("size" being here defined as 4 times rms). It has successfully delivered 70 μA to ISAC's west target station over long periods of time. Post-mortem analysis revealed no localized melting of the target. A key factor in developing the new tunes was reported last year – the discovery of an incorrect description of the beam transport from the stripper foil through the fringe field of the cyclotron to the beam line. Since this discovery, we now achieve very good agreement between measured and calculated beam envelopes. This is shown in Fig. 253.

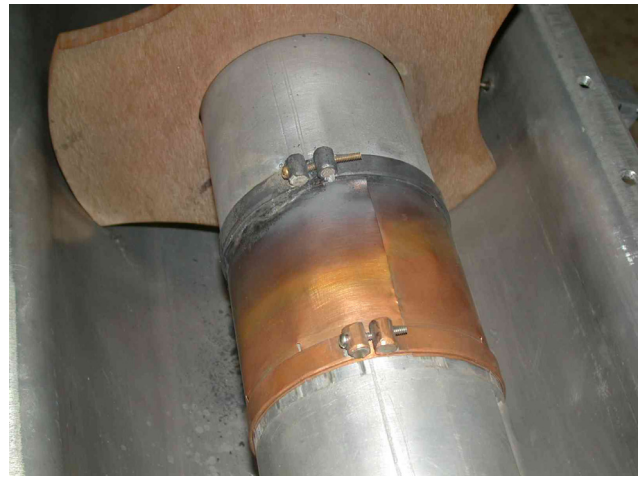
Fig. 256. Burnt spot at transmission line inner conductor joint.

A complete overhaul and cleaning of all spark and burn spots was made on the transmission-line matching section. Six new aluminum inner-conductor joint sleeves were installed. These replaced old copper ones

that had failed in a few locations because of electrochemical corrosion (see Fig. 256). Also, eight new polypropylene disk spacers have replaced old unreliable insulators.

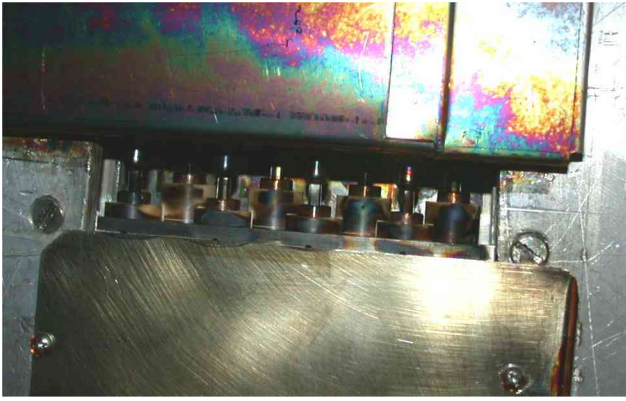
Fig. 257. Correction plate wire way insulators coated due to discharge.

Thirty-two new correction plate (CP) HV cables were run from the power supplies to the tank lower feedthroughs and the old cables were removed from the vault basement. There was a plan to refurbish in-tank CP wire ways. However, during the shutdown it was decided to limit this intervention only to cleaning the ceramic insulators and covering them for protection against multipactor discharge (see Fig. 257).

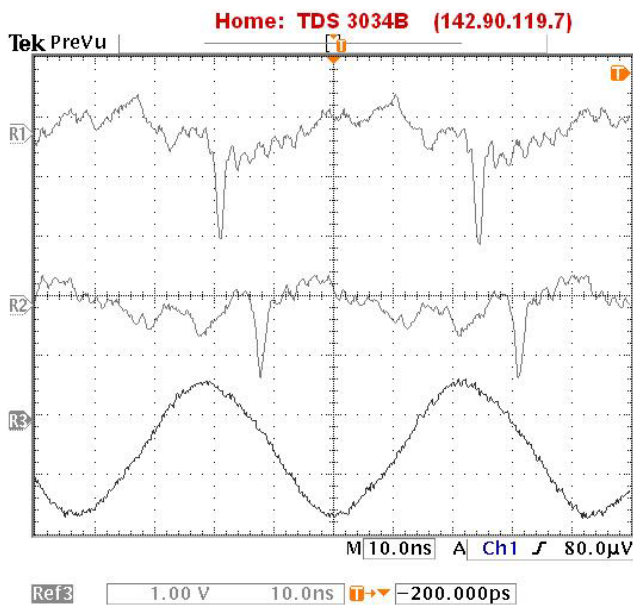
Fig. 262. Waveform of the signal from both high frequency outputs of the wideband probe (the two upper curves) and the rf sine wave (fundamental) measured with a 350 MHz scope. The horizontal scale is 10 ns/div.

Several hours in two beam development shifts in May were dedicated to studies of the broadband functionality of the new probe. For the high-frequency outputs a signal-to-noise ratio of about 4 at 250 nA average current and 0.1% duty cycle was measured in the presence of rf noise from the cyclotron (see Fig. 262). Time-structure as short as 1 ns was resolved. Although the probe meets design specification and shows good performance, the signal-to-noise ratio is relatively low. An especially strong noise signal is induced in the probe by the cyclotron booster. Additional effort will be required to further filter out this noise.

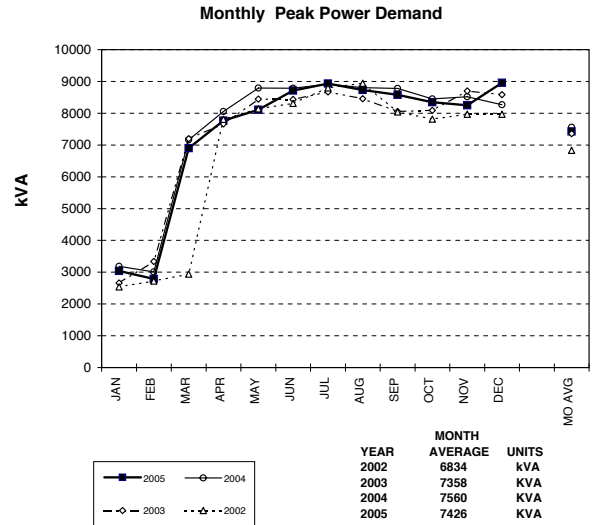
Fig. 263. Monthly peak power demand – four year comparison.

For the first time in five years the monthly averaged, peak-power demand took a turn downward, dropping by 1.8% from 7,560 kVA to 7,426 kVA (Fig. 263). The annual maximum peak demand, reached in December (8,957 kVA), was a mere 0.5% higher than the previous year. The electricity consumption also bucked the previous trend, decreasing a good 5% from 58.4 GWh to 55.5 GWh (Fig. 264). The largest monthly consumption was recorded in August (6.0 GWh) and was approximately 3.4% less than last year’s maximum. These declines are indicative of longer maintenance activities on site.
